Radiation-Induced Effects in Multiprogrammable Pacemakers and Implantable Defibrillators

RODRIGUEZ, F., ET AL.: Radiation-Induced Effects in Multiprogrammable Pacemakers and Implantable Defibrillators. Twenty-three multiprogrammable pacemakers and four implantable cardioverter defibrillators (ICDs) containing either complementary metal-oxide semiconductor (CMOS) or CMOS/Bipolar integrated circuit (IC) technology were exposed to 6-MV photon and 18-MeV electron radiation at various dose levels. Of the 17 pacemakers exposed to photon radiation eight failed before 50 Gy, whereas four of the six pacemakers exposed to electron radiation failed before 70 Gy. Photon scatter doses were well tolerated. For the ICDs detection and charging time increased with accumulated radiation dose, the charging time increased catastrophically at < 50 total pulses delivered when compared with the charging time of six implanted ICDs. Sensitivity and output energy delivered by the ICD pulse were constant during the test. It was found that devices using the shorter channel length IC technology (i.e., 3 μm CMOS) were per se harder to ionizing radiation than the devices using larger channel length IC technolog

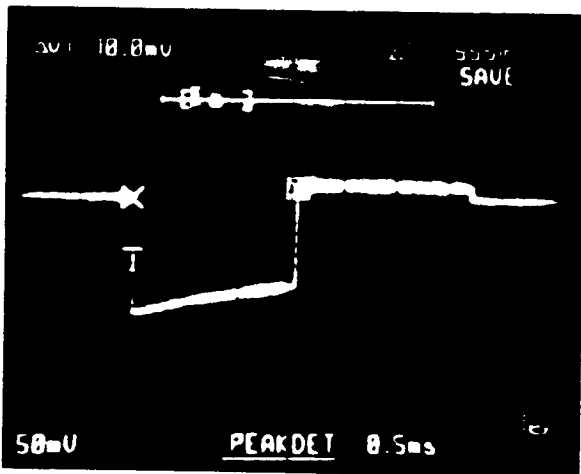
Figure 1 shows the pulse output at baseline for a typical pacemaker. Figures 2 and 3 show the output signal for A4 after an accumulated photon radiation dose of 25 Gy and the output signal for B4 after an accumulated photon radiation dose of 146 Gy, respectively. It should be noted that the signal amplitude is only 100 mV for A4 and the pulse width for B4 changed from 1.5 msec (baseline value) to around 30 msec after the respective radiation dose level.

Figure 2. Pulse output for A4 after 30 Gy photon radiation.

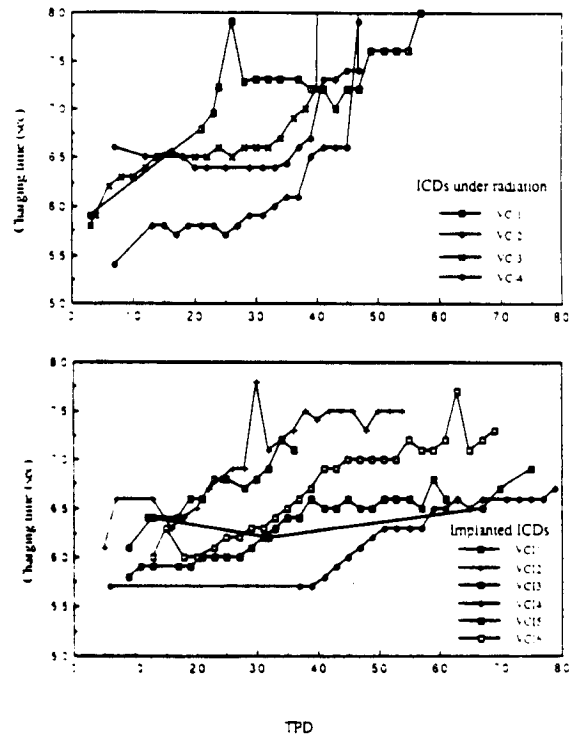
As shown in Figure 4, the charging time of the irradiated defibrillators increased catastrophically at < 50 total pulses delivered (TPD) when compared with a control group of six patients with implanted ICDs. These implanted ICDs showed no tendency to a catastrophic increase even after 79

Figure 4. Charging time versus total pulse delivered (TPD).

From Table III one can see that two of the ICDs (VC-2 and VC-4) failed before getting to the battery depletion bias level. Moreover, the fact that the charging time of the four devices increased catastrophically at < 50 TPD when compared with the charging time of the six implanted devices (See Fig. 4) implies that the photon radiation dose had a direct effect over the charging time of the four ICDs.

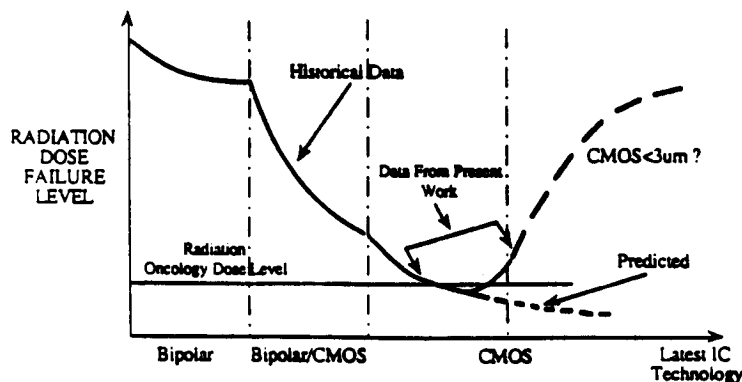
Large channel length technology has thicker gate oxide. Radiation sensitivity of MOS devices is highly dependent on oxide thickness. Therefore, from Table II one can see that the CMOS IC technology with the shorter length channel is harder to radiation than the ones with longer length channels and combined bipolar technology. It should be noted that 43.5% of the devices failed at dose levels < 50 Gy and 17.4% at dose levels between 51 and 100 Gy. Nevertheless, most of the devices that failed at the above radiation dose levels used relatively old IC technologies (i.e., 8 μm CMOS and 5 μm CMOS/20 V Bipolar). Moreover, the IC technology of the six pacemakers that remained operative at the end of the test after a radiation dose of 246 Gy photons or 300 Gy electrons was 3 μm CMOS. The high dependence of radiation sensitivity on oxide thickness of MOS devices accounts for the above results.¹⁷ Finally, for the energy levels used, there was no appreciable difference between the effects caused by either photon or electron radiation.

Figure 7. Relationship between pacemaker IC technology and radiation dose level failure.
