Radiation-Induced Effects in Multiprogrammable Pacemakers and Implantable Defibrillators

RODRIGUEZ, F., ET AL.: Radiation-Induced Effects in Multiprogrammable Pacemakers and Implantable Defibrillators. Twenty-three multiprogrammable pacemakers and four implantable cardioverter defibrillators (ICDs) containing either complementary metal-oxide semiconductor (CMOS) or CMOS/Bipolar integrated circuit (IC) technology were exposed to 6-MV photon and 18-MeV electron radiation at various dose levels. Of the 17 pacemakers exposed to photon radiation eight failed before 50 Gy, whereas four of the six pacemakers exposed to electron radiation failed before 70 Gy. Photon scatter doses were well tolerated. For the ICDs detection and charging time increased with accumulated radiation dose, the charging time increased catastrophically at < 50 total pulses delivered when compared with the charging time of six implanted ICDs. Sensitivity and output energy delivered by the ICD pulse were constant during the test. It was found that devices using the shorter channel length IC technology (i.e., 3 μm CMOS) were per se harder to ionizing radiation than the devices using larger channel length IC technolog

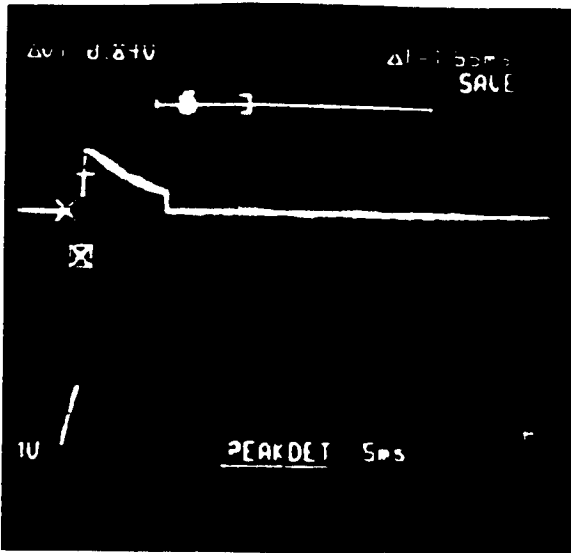
Figure 1 shows the pulse output at baseline for a typical pacemaker. Figures 2 and 3 show the output signal for A4 after an accumulated photon radiation dose of 25 Gy and the output signal for B4 after an accumulated photon radiation dose of 146 Gy, respectively. It should be noted that the signal amplitude is only 100 mV for A4 and the pulse width for B4 changed from 1.5 msec (baseline value) to around 30 msec after the respective radiation dose level.

Figure 1. Pulse output at baseline for a typical pacemaker.

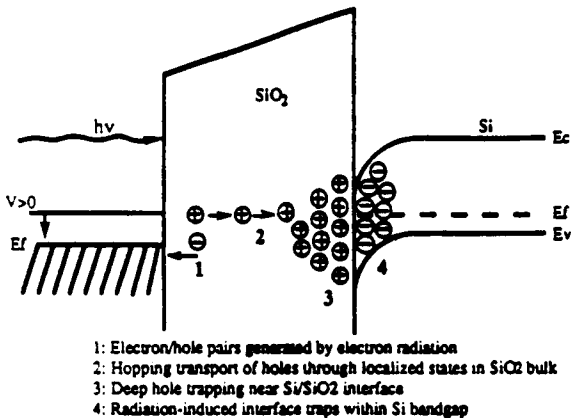
The most sensitive parts of an MOS structure to ionizing radiation are the silicon dioxide layers. The cumulative radiation damage to these layers consist of three components: The build up of trapped charge in the oxide, the increase in the number of interface traps, and the increase in the number of bulk oxide traps.¹²

Figure 5 shows the process of the ionizing radiation-induced effects in an n-channel transistor. Zones 1, 2, and 3 show the build up of trapped charge in the oxide, whereas 4 shows the radiation induced interface traps at the SiO₂/Si interface. The rate at which an ionizing radiation dose is delivered to a device can have a transient effect on it. This effect occurs due to the radiation-induced photocurrents generated by high dose rate and begins to be appreciable for dose rates > 10⁶ rad/sec. In our case we are dealing with relatively low radiation pulse dose rates (< 10⁴ rads/sec) so at these levels there is no significant dependence on dose rate.

Figure 5. Schematic of the ionizing-radiation induced effects on an MOS structure under positive gate bias. 1 = electron/hole pairs generated by electron radiation; 2 = hopping transport of holes through localized SiO₂ bulk; 3 = deep hole trapping near Si/SiO₂ interface; 4 = radiation-induced interface traps within Si bandgap.

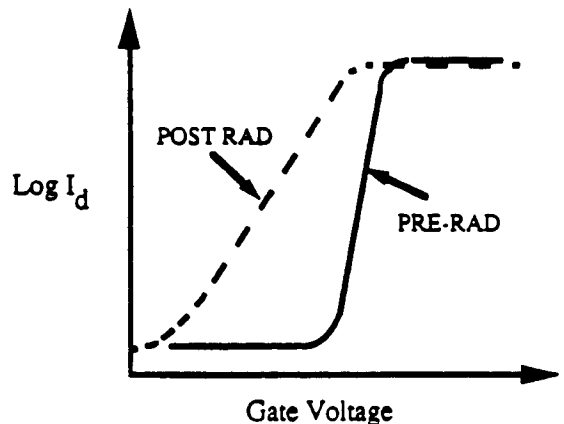
Figure 6 shows the drain current as a function of gate voltage for an n-channel MOS transistor before and after the irradiation. The curve shifts to the negative direction causing the threshold voltage to be more negative meaning that a less positive voltage is required to turn the transistor on. The curve is also less steep, which means that a greater change in applied bias is required to cause the same change in current as before the irradiation.

Figure 6. Logarithm of the drain current as a function of gate voltage before and after radiation on an n-channel MOS transistor.
